# Gold Ridge Tailings Storage Facility Assessment

## *Solomon Islands*

### United Nations Disaster Assessment and Coordination (UNDAC) Mission

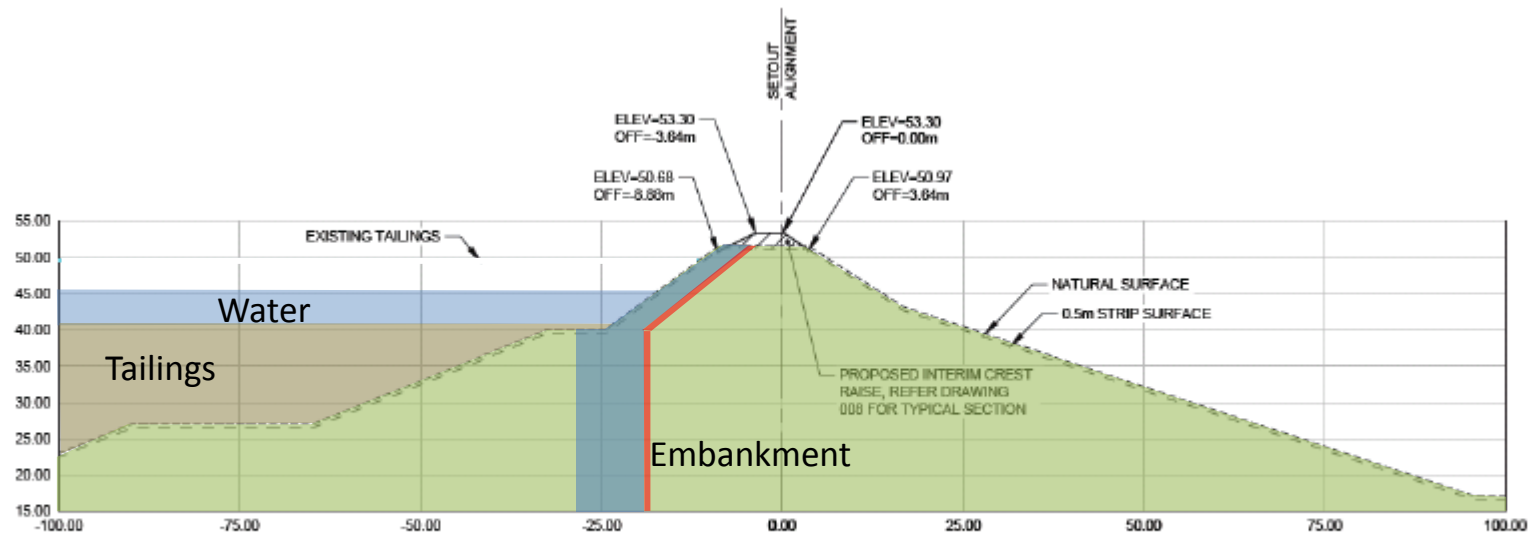
# July 2005 Water Levels in TSF

- December 2003: RL 44.5 (7 m below crest and 5 below spillway)
- July 2005: RL 46.3 (5.6 m below crest and 5 below spillway)

Figure 6 - Cross section of current crest raise. (Golders, 2013)

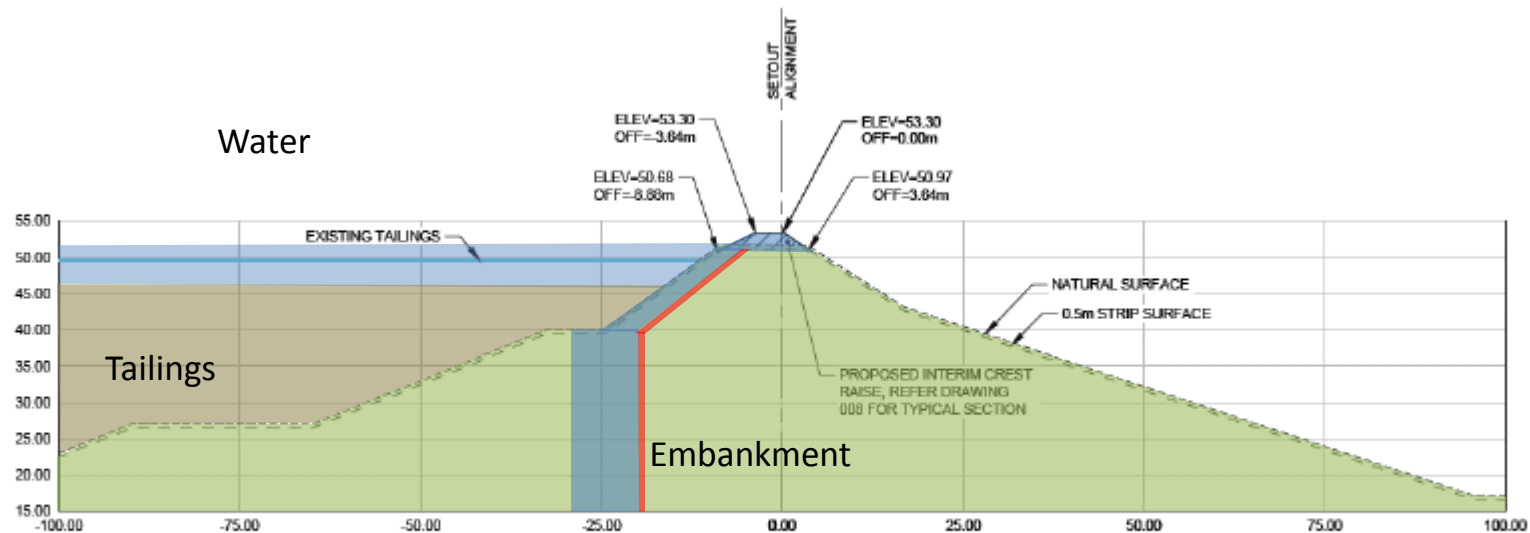
# April 2014 Water Levels in TSF

- Design drawings tailings not above 46 mRL
- Water level estimate at 51.6 mRL (5.6 of water)
- 0.9 of vertical water on section without filter

Figure 6 - Cross section of current crest raise. (Golders, 2013)

4. Continue dewatering sampling and monitoring program as laid out in discharge license, with the inclusion of additional sampling points
5. Construct tailings storage facility to design drawings or conduct analysis for the current design

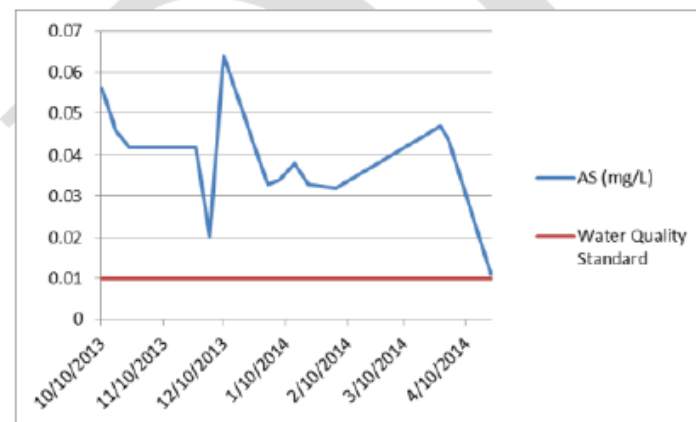
Chart 1: Arsenic levels in the DP pond

Levels measured 22 April, 2014

TSFP02	TSFP03	TDP	Limit value
Arsenic (mg/L)	<b>0.013</b>	<b>0,014</b>	<b>0,017</b>	0,01
Cyanide, free (mg/L)	<0,004	<0,004	0,007	0,07

- Dewatering without treatment as emergency action only:
  - License, pump reparations, installment, continuous water quality monitoring, community informing/notification
  - Would take approx. 160 days (at safe dilution level)
- Dewatering with treatment
  - Preferred option
  - Re-commission water treatment plant
  - Find a solution for storage and analysis of treated water prior to release
